Failure analysis of the impellers of coke plant

Souvik Das*, Goutam Mukhopadhyay, Sandip Bhattacharyya

R&D and Scientific Services, Tata Steel Ltd., Jamshedpur 831 001, India

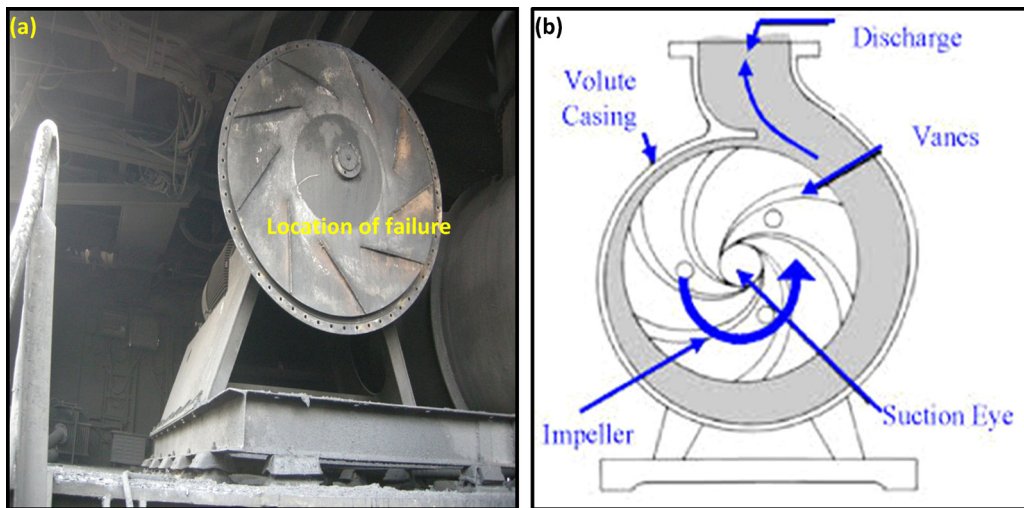
Centrifugal pumps are turbo machines used for transporting air or gas by raising a specified volume of the flow to a specified pressure level. The basic centrifugal pump components are: the casing, the bearing housing, the pump shaft and the impeller. As the impeller rotates, the gas is accelerated by the rotating element within the confined space created by the volume of the compressor's casing. The gas is compressed as more gas is forced into the volute by the impeller blades. The pressure of the gas increases as it is pushed through the reduced free space within the volute. In these studies premature failure investigation of impeller blade was carried out. The component functioned during the CGC gas intake cycle. The component rotates at 1480 rpm with a volumetric flow of 720 m³/min of flue gas with temperature about 200–300 °C. The expected life of the component is 5 years while the component failed within 3 years of its service (Fig. 1).

Fig. 1. (a) The assembly site of the failed impeller; (b) schematic drawing of the impeller.

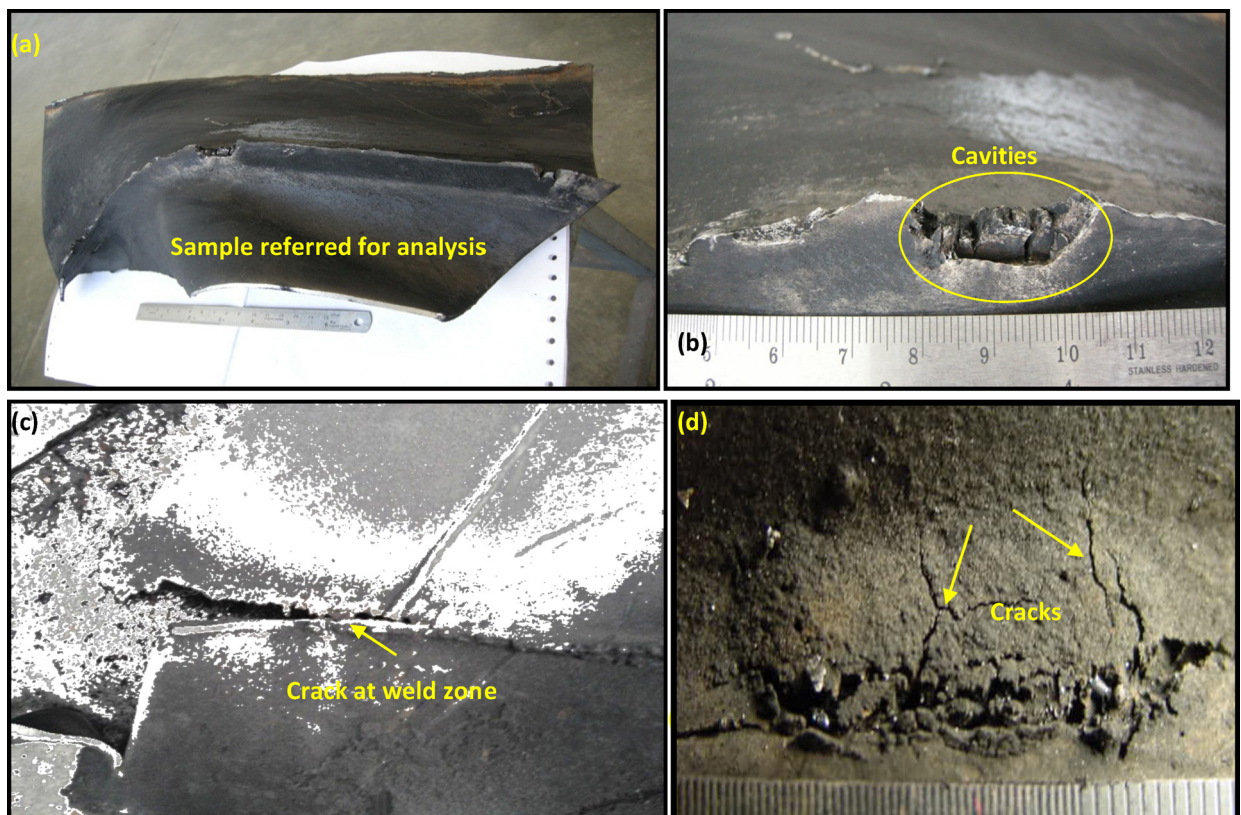
Plant Visit was conducted to understand the problem. During plant visit it has been observed that after premature failure of the component several areas were detected on the blades and at the attachment zone of the blades and the hub where weld-repair work on the cast was performed. A triangular piece of the first centrifugal blower impeller blade was submitted for metallurgical analysis of the cause of cracking. The piece had been extracted from the rest of the blade, as referenced Fig. 2a. It contained an exposed surface of a crack that extended slightly beyond the assembly weld from the leading edge

Fig. 2. (a) Full view of sample referred for analysis; (b–d) cracks at various location of the component.

where cavities were observed (Fig. 2c and d). A crack which encompassed the leading edge and extended down one side (pressure side) of the blade sample was observed. Corrosion pitting was noted along the leading edge and along the crack path in the blade edge, the suspected crack initiation area.

Use of low carbon varieties, i.e. 304L or 304LN austenitic stainless steels which are resistant to sensitization is recommended for use in welded components exposed to prolonged service to avoid similar failures in future.

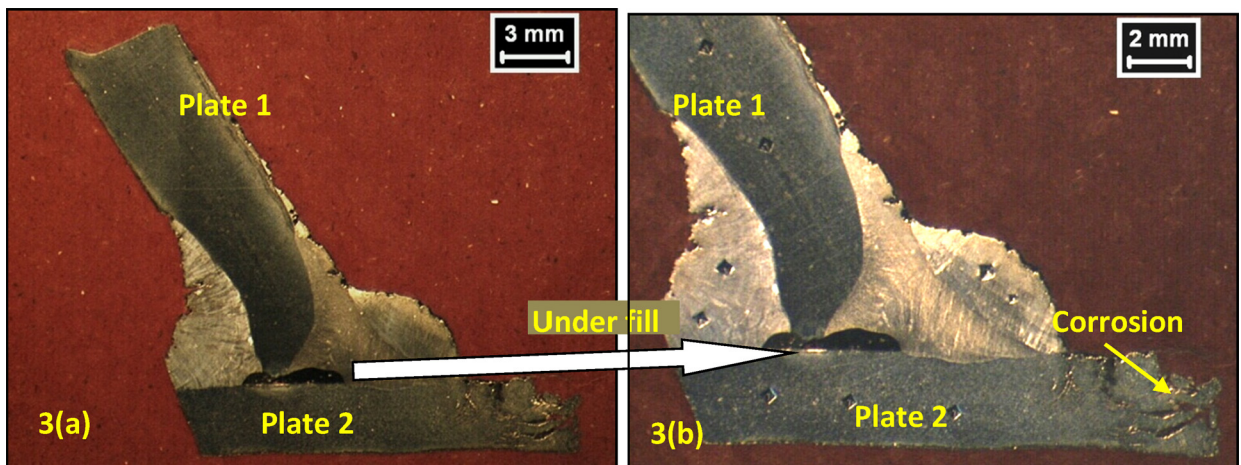
Small sample containing fracture surface were cut from the cracked blade and were mounted with resin, ground and polished using standard metallographic technique as shown in Fig. 3a. Macro and microstructural characterization was carried out using optical microscope (Leica, model: DMRX, Germany). Macro dual image of metallographic sample shows that under fill region is present in welded region. Closer view of sample as shown in Fig. 3b shows signature of corrosion adjacent to the weld region of the impeller blade.

Fig. 3. (a and b) Macro dual image of impeller.

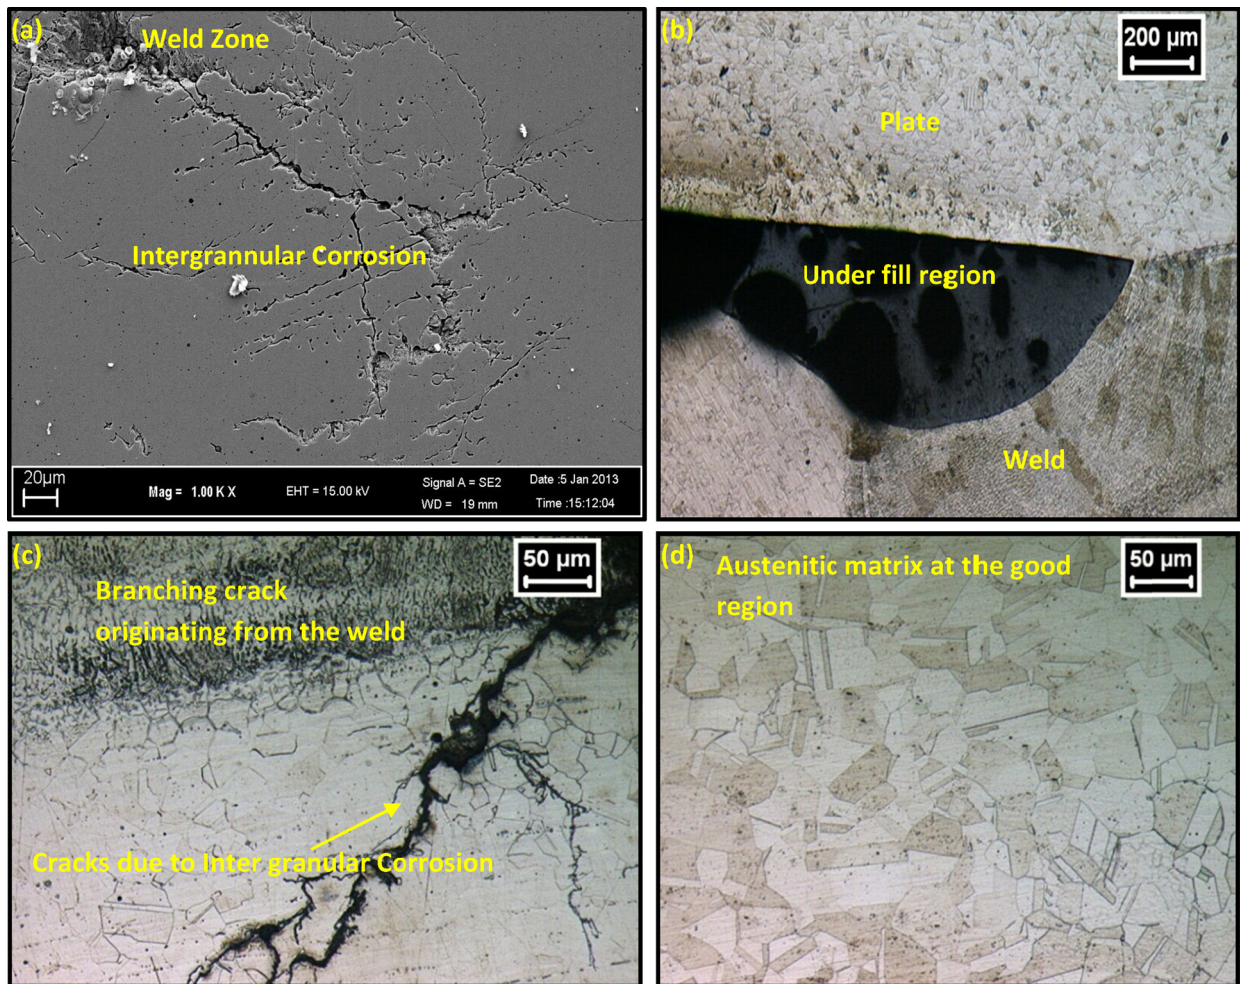
Un-etched microstructure of the impeller reveals cracks with branching (Fig. 4a). The polished samples were etched using aqua regia for microstructural study. Under-filled region in welding is observed from Fig. 4b. Under filled region in welding is detrimental because it acts as a stress concentration site. The microstructure from the weld zone showed several abnormalities. Severe intergranular corrosion (IGC) degradation has been observed in the microstructure (Fig. 4c). Micro cracks and cracks have been observed at several locations, mostly originating from the weld zone. However the microstructure from the un-effected region of the sample shows an austenitic matrix without any irregularity (Fig. 4d).

Fig. 4. (a) Un-etched microstructure of the impeller and (b) under-filled region in welding is observed. (c) Microstructure from damaged portion of the sample. (d) Microstructure from good region of the sample.

The impeller of the coke plant failed due to material degradation caused by intergranular corrosion (IGC) due to sensitization.
